One-dimensional charring rate of Glulam manufactured from Malagangai (*Potoxylon melagangai*) species treated with fire retardant

Abstract: This study investigates the one-dimensional charring behavior of glued laminated timber (glulam) manufactured from Malagangai (*Potoxylon melagangai*) under standard fire exposure conditions. Specifically, the research evaluates the effectiveness of a fire-retardant coating in enhancing the fire resistance of glulam. The fire retardant used in this study is a waterborne, transparent formulation designed for application on both newly processed and preservative-treated timber surfaces, offering an additional layer of protection against fire. To assess the fire performance of both treated and untreated glulam specimens, a fire resistance test was conducted in accordance with ISO 834 (equivalent to BS 476: Part 20). The charring rate of the specimens was measured based on the guidelines outlined in EN 13381-7:2014. The experimental findings indicate that while the application of the fire-retardant coating provides some level of protection, its impact on reducing the charring rate is relatively minor. The treated glulam exhibited a charring rate of

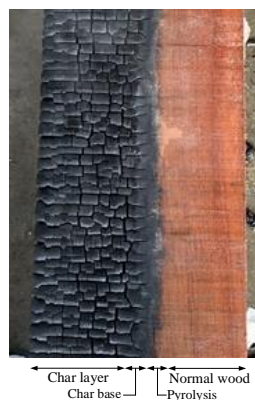
Fig.1. Charred sample showing charred layer, pyrolysis and normal wood

When timbers are exposed to flames, these materials begin to ignite at a surface temperature of approximately 270 °C. According to the structural fire design guidelines outlined in Eurocode 5 [5], the onset of charring is defined as the moment when the surface temperature of the timber reaches 300 °C. As the fire continues, the temperature within the timber increases, causing the boundary between the unaffected wood and the pyrolysis zone to gradually shift deeper into the material. The rate at which the boundary between burnt and unburnt wood progresses through the cross-section of the material when exposed to fire is referred to as the charring rate of timber. The charring rate is determined from the distance between the outer surface of the original member and the position of the char-line over the time of exposure [6]. The char layer acts as an insulation layer, which slows the burning and protects the rest of the cross section (see Charred samples for Light Red Meranti after 30 minutes of one-dimensional fire exposure in **Fig. 1**). In recent years, charring rates have gained significant attention from researchers and structural designers who seek to assess the loss of load-carrying capacity in timber beams and columns during and after fire tests [7–9].

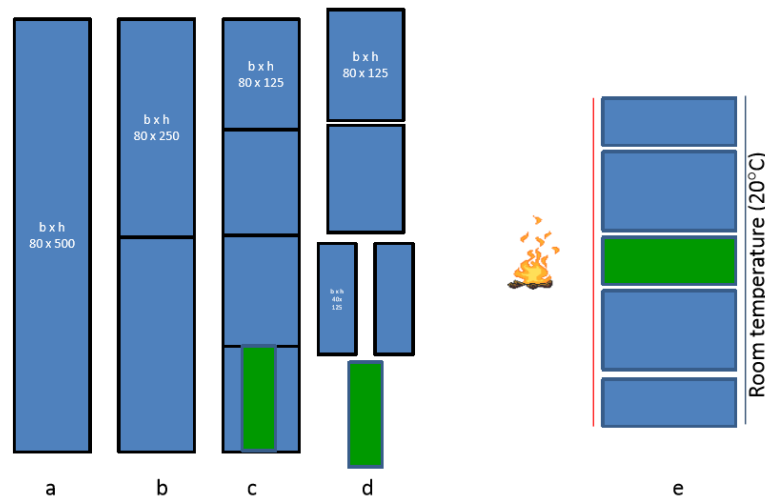
Fig. 2. (a) to (d) illustrate the assembly of the charring test specimen (approximate width: 270 mm) made from a glulam beam measuring 80 mm \times 500 mm.

The received glulam beams were stored in a climate chamber (20 $^{\circ}$ C, 65% RH) for three days. The charring test specimens were prepared at SP Wood Technology approximately one week before the fire tests. The one-dimensional fire specimens were cut into different sections as shown in **Fig. 2**.

These specimens were made from centrally instrumented beams, taken from the lower side of each glulam beam (see **2d**) and face glued to form a beam of with a final geometry of approximately 1650 mm \times 270 mm \times 120 mm (length \times width \times depth) and consisted of multiple sizes. The timber density, including moisture content, was determined using end cuts from the glulam beams (approximately 365 mm in length). The depth of the instrumented beam, along with its density and moisture content, was measured before the test at both ends of the charring test specimens (see **Table 4**). The verification and evaluation of charring rate of the specimens were conducted in accordance with EN 13381-7 [17].

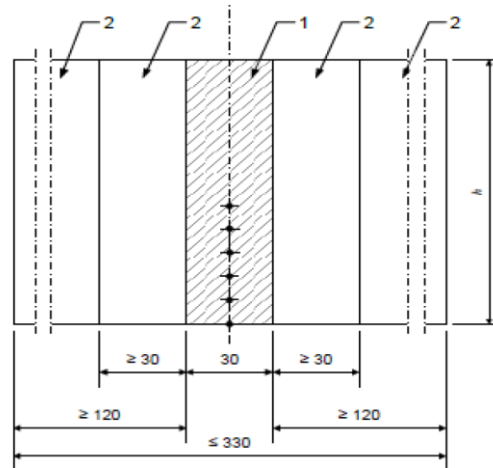
Fig. 3. Charring specimen with one and three instrumented beams protected by outer beams as given by EN 13381-7 [17].

Both charring test specimens were equipped with three measurement stations, each containing eight thermocouples. **Fig.3** and **Fig. 4** show the instrumented beam with thermocouple placements, as recommended in EN 13381-7 [17]. The thermocouples were positioned at the center of the beam, with a minimum horizontal distance of 6 mm.

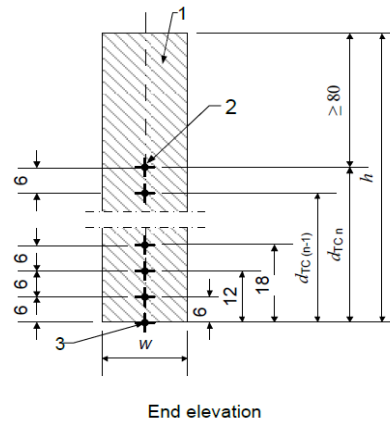
Fig. 4. Side elevation of the instrumented beam, dimensions in mm

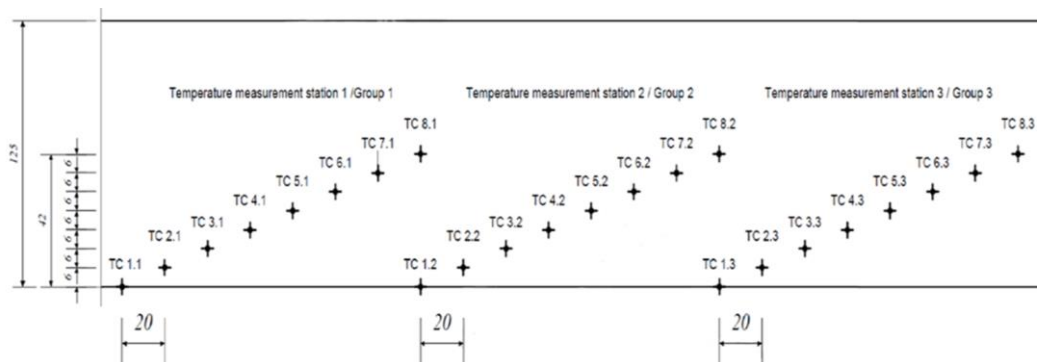
Fig. 5. Instrumentation of the instrumented beam of the charring test specimens with 3 temperature measurement stations.

Type K thermocouples were used for instrumentation, inserted from both sides of the instrumented beams with a horizontal spacing of 20 mm. Both charring test specimens had approximate dimensions of 1650 mm \times 270 mm \times 120 mm (length \times width \times depth). The density, including moisture content, was determined using end cuts from the glulam beams, each approximately 365 mm in length. **Fig. 5** illustrates the arrangement of 24 Type K thermocouples, organized into three stations or groups, each comprising eight thermocouples. The thermocouples were positioned with a total vertical spacing of 42 mm and a horizontal spacing (along the length) of 20 mm.

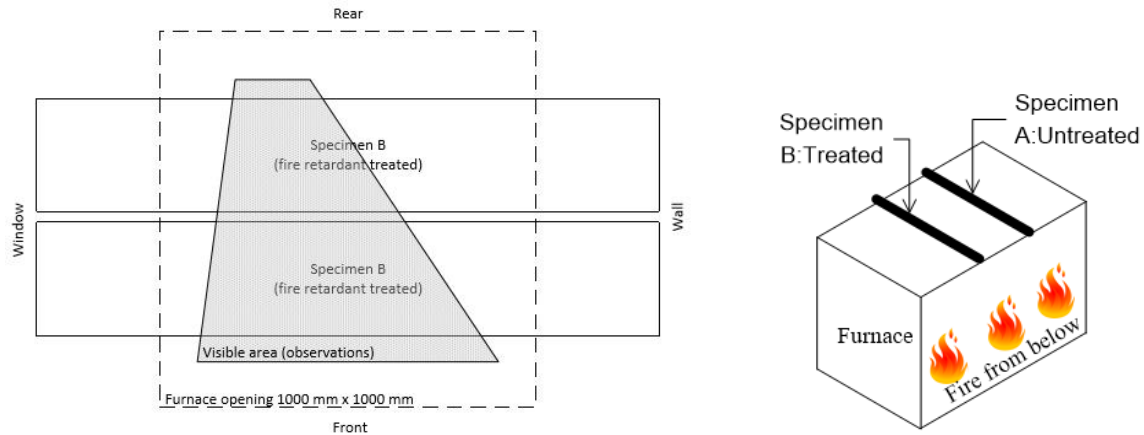
Fig. 6. Arrangement of the specimens on the furnace

Test specimens A (untreated) and B (fire-retardant treated) were mounted on the model-scale furnace by SP (see **Fig. 6**). A strip of stone wool, 50 mm wide with a density of 30 kg/m^3 , compressed to approximately 20 mm, was placed between the test specimens.

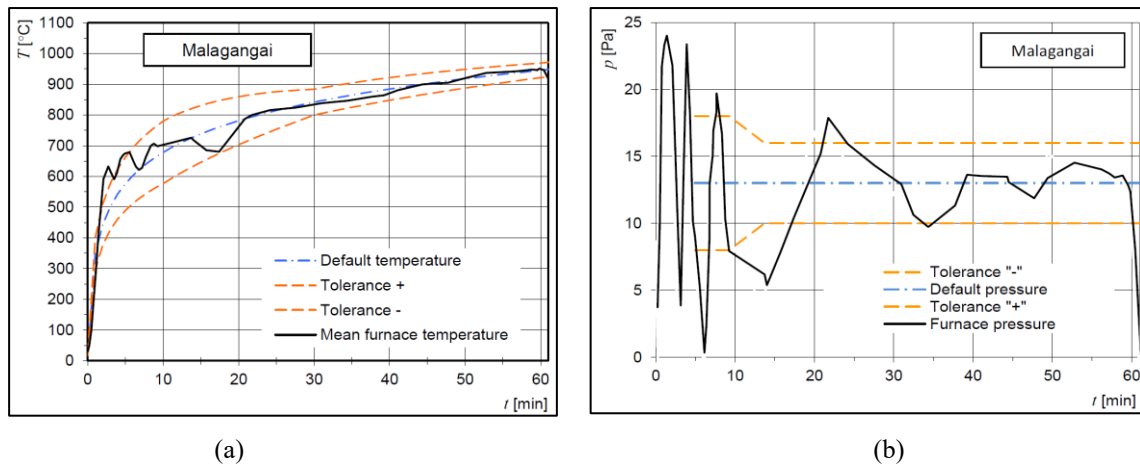
Fig. 7. Furnace and the default temperature with the tolerated deviation specified in EN 1363-1 for; (a) untreated glulam and (b) fire-retardant treated glulam

Fig. 7 illustrate the furnace temperature and pressure in comparison with the default temperature and its tolerated deviation as specified in EN 1363-1 for Malagangai glulam, untreated and fire-retardant treated. During the first five minutes, when the temperature was below 500 °C, the furnace temperature graph appeared moderately smooth. However, upon exceeding 600 °C between 7 and 20 minutes, fluctuations in the temperature curve were observed. After the 20-minute mark, the temperature stabilized and aligned with the default temperature.

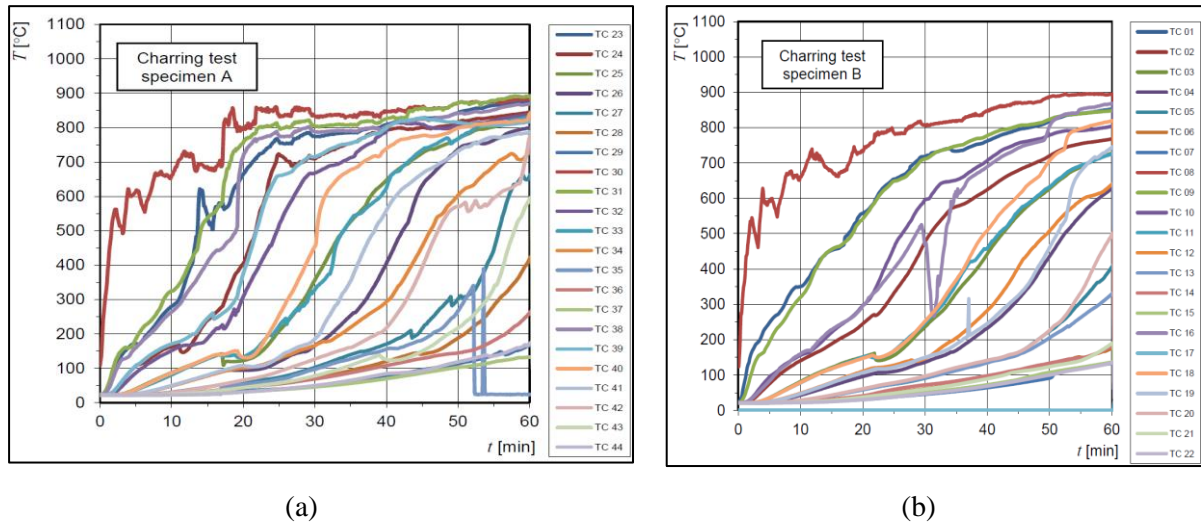
Fig. 8. Temperature measurements in charring test for; (a) specimen A (untreated) and (b) specimen B (fire retardant)

Timber measurements in the test specimens during fire exposures are given in **Fig. 8** for untreated and treated glulam beams. From the data plotted in **Fig. 8**, it is apparent that the temperatures for both specimens are equal and thus valid for comparison purposes.

A clear trend of increasing temperature is observed from the start (0 minutes) up to minute 30. All thermocouples functioned properly, and this type of TC was able to resist temperatures up to 1200 °C. Both specimens show an initial rapid increase in temperature within the first 10 minutes, especially for the thermocouples positioned closer to the fire-exposed side. After this initial rise, the temperature continues to increase more gradually before stabilizing for some thermocouples. After exceeding 800 °C, the temperature curve remains relatively unchanged until minute 60. This is because of the formation of char prevents the fire from spreading deeper into the timber core [10, 19, 20]. The highest temperatures (~900-1000 °C) are reached around 50-60 minutes, particularly for the most exposed layers.

Specimen A shows greater fluctuations in temperature, suggesting more severe charring and potential structural instability. The temperature rise is more irregular, which may indicate delamination, cracks, or structural degradation occurring at different time points as indicated at 51:15 (min: sec) in **Table 5**. Meanwhile, specimen B demonstrates a smoother temperature progression, which could be attributed to the fire-retardant treatment or better integrity of the material under fire exposure. Specimen A reaches higher peak temperatures faster, which may indicate more aggressive burning compared to Specimen B.

Specimen B likely has better fire resistance compared to Specimen A, as evidenced by more gradual heating and less variation in temperature readings. The significant fluctuations in Specimen A suggest greater structural degradation over time, leading to potential delamination or failure. The fire-retardant coating in Specimen B appears to have effectively slowed down heat penetration and charring.

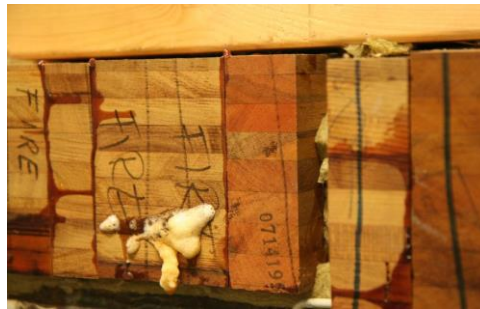
Fig.9. Moisture evaporation and foam on the surface of the charring test specimen B (fire-retardant treated)

At initial heating phase (16:54 – Image 1), the surface appears to be in the early stages of thermal exposure, showing initial discoloration and surface cracks due to heat expansion. Moisture evaporation and pyrolysis begin, but the material is still largely intact. Moisture evaporation and liquid was observed seeping from the glue lines of Specimen B can be seen in **Fig. 9**.

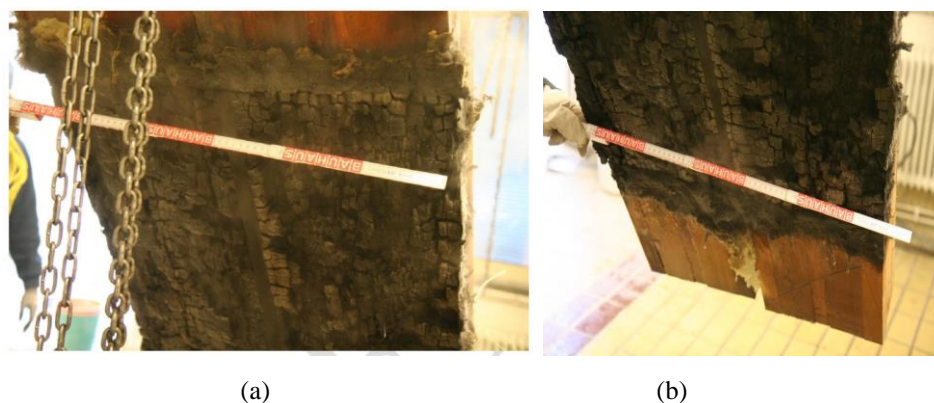
Fig. 10. Charred specimens after extinguishing work; (a) Wall side (top end in the image) and (b) Window side (bottom end in the image) with fire retardant treated specimen (left) and untreated specimen (right)

There is a notable difference between untreated timber and fire-retardant-treated timber, with the latter significantly reducing flame spread, as previously discussed. **Fig. 10** shows the surface conditions of the specimens after approximately 60 minutes of fire exposure from both the wall and window sides. These images clearly show that glulam without fire retardant experiences greater material loss.

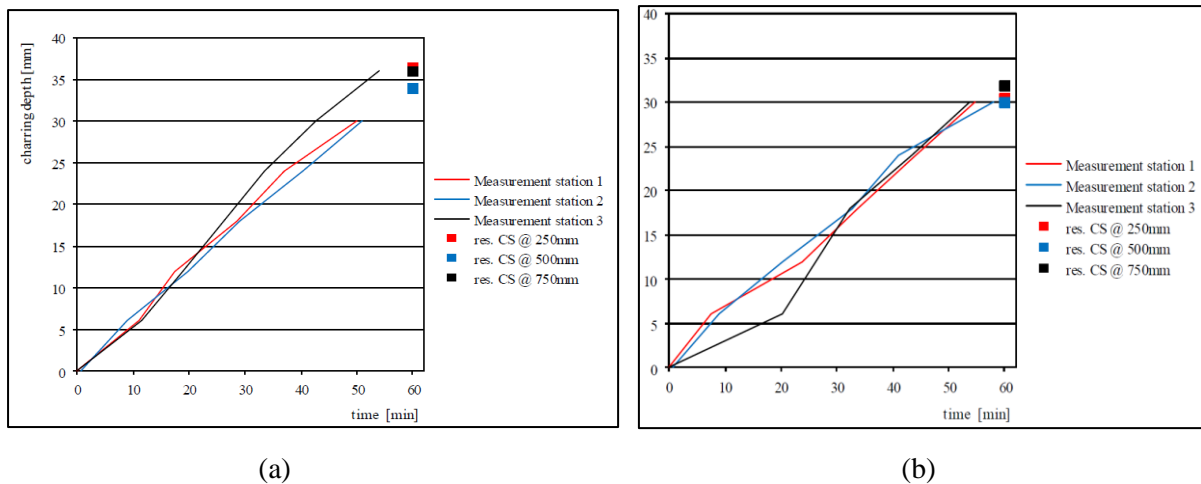
Fig. 11. Charring depth and the residual cross-section measurements at Stations 1, 2 and 3 for; (a) Specimen A and (b) Specimen B

Fig.11 illustrates the relationship between char depth and time for Specimens A and B at Stations 1, 2, and 3, corresponding to timber sections located at 250 mm, 500 mm, and 750 mm along the specimen length, respectively. Both graphs indicate an increase in char depth over time, demonstrating the typical behavior of timber exposed to fire. Initially, the charring rate is relatively slow, but after approximately 10–20 minutes, it accelerates as the heat penetrates deeper into the material.

The graph for untreated glulam shows a slight variation in char depth among measurement stations, with the third station (750 mm) experiencing the most significant charring towards the end. In contrast, the graph for fire-retardant treated glulam shows a more consistent charring rate across the three measurement stations, suggesting more uniform fire exposure. At the 60-minute mark, both graphs indicate a final char depth of approximately 30 to 35 mm. However, in the graph for untreated glulam, the residual cross-section of timber at 750 mm appears to be more affected compared to the graph for fire-retardant treated glulam.
