Addressing the challenges of electric pole design and material selection: A review of current practices and future directions

Ajibola Ibrahim Quadri, Williams Kehinde Kupolati, Chris Ackerman, Chibueze Godwin Achi, Jacques Snymans, Julius Musyoka Ndambuki

Civil Engineering Department, Tshwane University of Technology, Pretoria 0183, South Africa

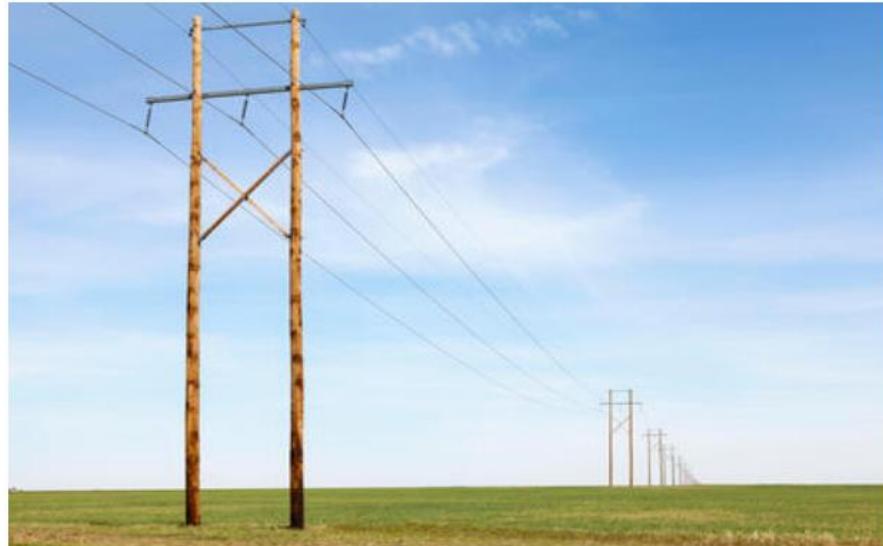
Fig. 2 Wooden poles from wind farms in Kiowa County Oklahoma [15]

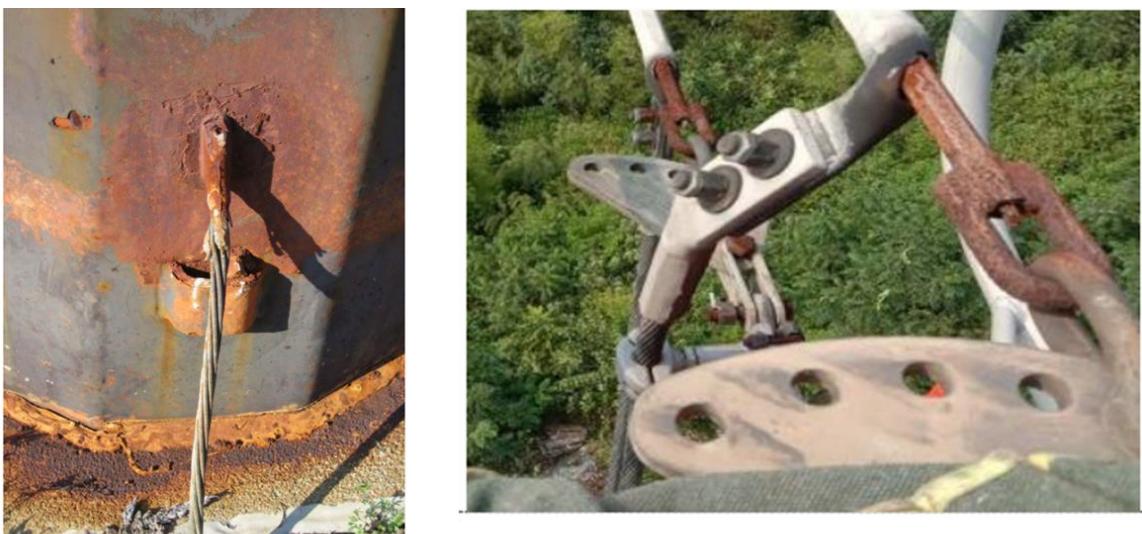
Fig. 7 Corroded steel poles and tower investigated [45,47].

Byrd [45], tested some electric steel poles, **Fig. 7** (left), according to the International Association of Corrosion Engineers Standards [46], “Miller LC4 high resistance test meter, and a copper sulfate cell”. A 0.2-volt was typically compared to a corrosion-protected value of higher than 0.85 volts. This infers that the pole is heavily corroded, with little discrepancy between copper and steel materials as observed in the electromotive series. The lower-in-grade steel is predominantly corroded oxide with slight mechanical significance. Liu et al. [47] investigated the strain clamp steel-anchored corrosion damage of a 500 kV transmission line, a part shown in **Fig. 7** (right), by adopting a mechanical properties test, macroscopic observation, composite analysis, and SEM analysis. It was observed that the corroded clamps had complex shapes, which are not convenient for anticorrosion coating since the components are welded. The tensile stresses were cumulated at the corroded part. It was pointed out that the gradual corrosion of the steel anchorage for over 30 years without attention resulted in the natural corrosion damaging the galvanic layer. According to an investigation by [48], steel poles kept for a long time underwent a different type of corrosion mechanism than when they were in use. When the poles were exposed to field conditions three years later, extensive red rust had formed at a part below the ground level and had spread outside, resulting in mechanical damage that was not what would have been expected under normal circumstances.
